*FOUNDATION  
INVESTIGATION  
REPORT*

*BARGE CANAL  
FAIRPORT - LOCK 33*

SOIL MECHANICS BUREAU  
NEW YORK STATE DEPARTMENT OF TRANSPORTATION

PHYSICAL CONDITION SURVEY  
BARGE CANAL - WESTERN SECTION  
FAIRPORT TO LOCK 33  
P. I. N. 4940.29 - 101

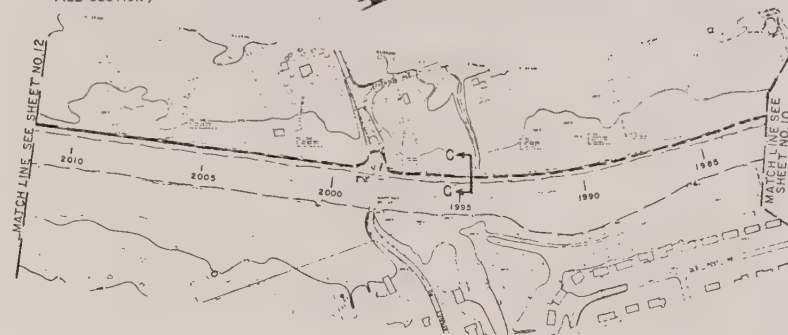
Q 1960 - Q 1982 - INTERMITTENT WET AREAS NOTED BELOW TOP WIDTH

NONE APPARENT - FURTHER INVESTIGATION OF TOWER FOUNDATION REQUIRED

- WIDEN EMBANKMENT TO THE MINIMUM LIMIT SHOWN ON SECTION B-B TO 1 ON 2.5 SLOPE BETWEEN Q 1960 AND Q 1969
- IN AREA WHERE CANAL LEAKAGE OCCURS, LEAKAGE CAN BE VIRTUALLY ELIMINATED BY EXTENDING EXISTING SHEETING AN ADDITIONAL 5± FEET 1' DEPTH FROM Q 1960 TO Q 1969 AND DRIVING NEW SHEETING FROM Q 1975 TO Q 1982

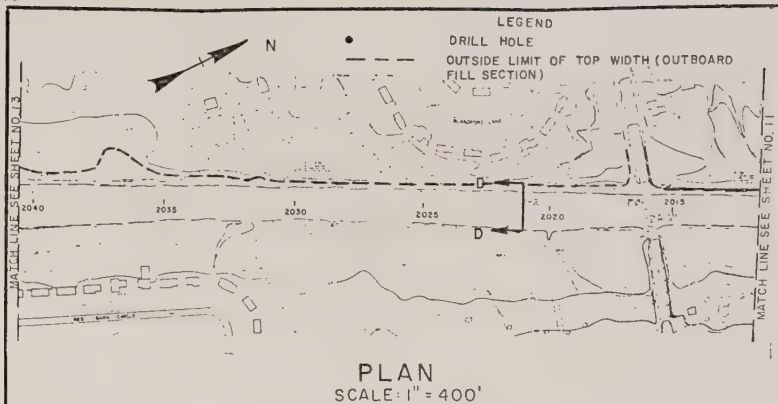
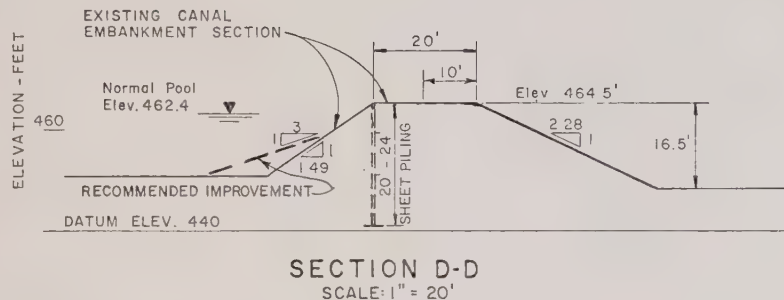
CANAL Q STATION 2012+00 - Q STATION 2040+00

Q 2012 - Q 2018 - INTERMITTENT SEEPAGE AREAS NOTED BEYOND TOE OF SLOPE  
- DYE TEST PERFORMED AT Q 2014  
Q 2018 - Q 2023 - SEEPAGE AREA NOTED AT Q 2019+50 AT TOE OF SLOPE  
- DYE TESTS PERFORMED AT Q 2018 AND Q 2021  
REMAINDER OF AREA - NONE
